Kashagawigamog Lake Shoreline Assessment Summary Report

June 2015

Submitted to the Kashagawigamog Lake Association by Watersheds Canada

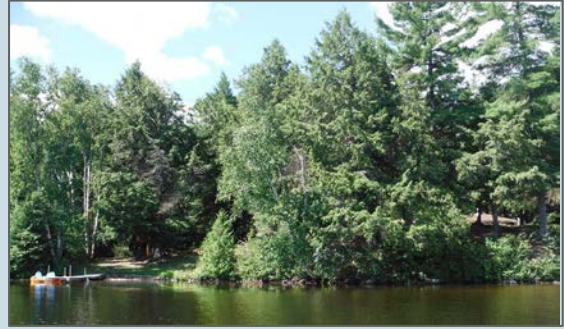
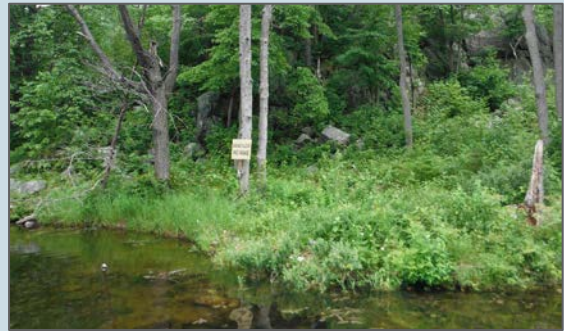
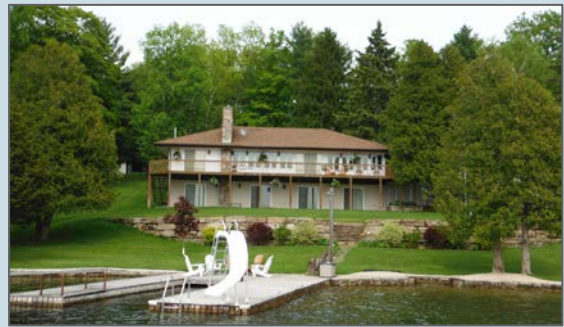
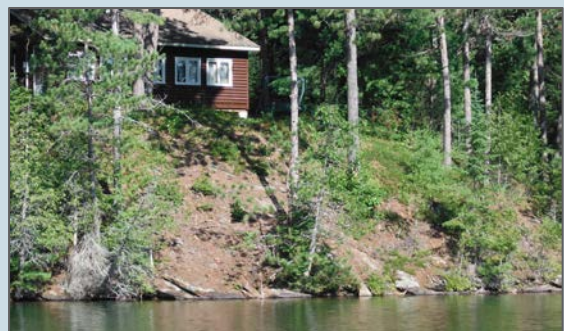
Photograph Example*

Natural – A healthy buffer of vegetation and/or a natural shoreline of sand or exposed rock that is undisturbed and undeveloped.

Regenerative – Natural vegetation has been removed in the past, but is in the process of growing back towards a natural state.

Ornamental – All natural vegetation has been removed and replaced with mowed lawn and other non-native vegetation; structures such as docks, decks, boathouses and boat ramps are predominantly present at the shore.

Degraded – Natural vegetation has been lost; soil erosion, undercutting of the bank, and/or exposed roots of shrubs and trees are significant.

***Note:** These photographs are examples of shoreline classes, not representing any specific shoreline property on Kashagawigamog Lake. There can be a range of variation in the classifications depending on the type of shoreline.

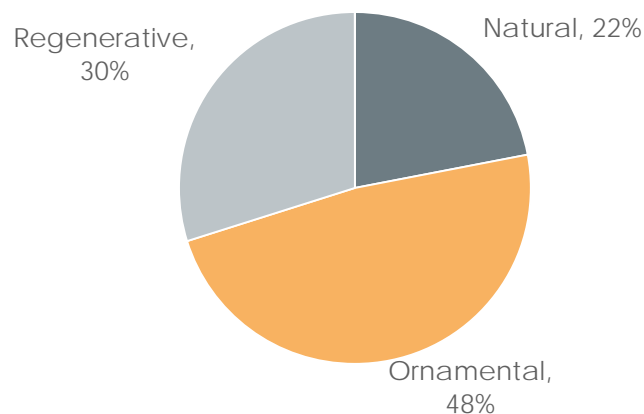
Figure 1 Property Classifications

On Kashagawigamog Lake, the relative majority of the shoreline (48%) is classified as ornamental, followed by 30% being regenerative and 22% being natural. It is recommended that shoreline property owners engage in naturalization projects to further decrease the ornamental percentage and increase the regenerative and natural percentages. Kashagawigamog Lake is above the recommended limit of 25% developed shoreline.

This presents an opportunity for residents of Kashagawigamog Lake to enhance the overall quality of the lake by maintaining, protecting and enhancing natural shorelines. To restore shorelines to more natural states, property owners are encouraged to take action. Regenerative properties should be encouraged to maintain their properties in a natural state.

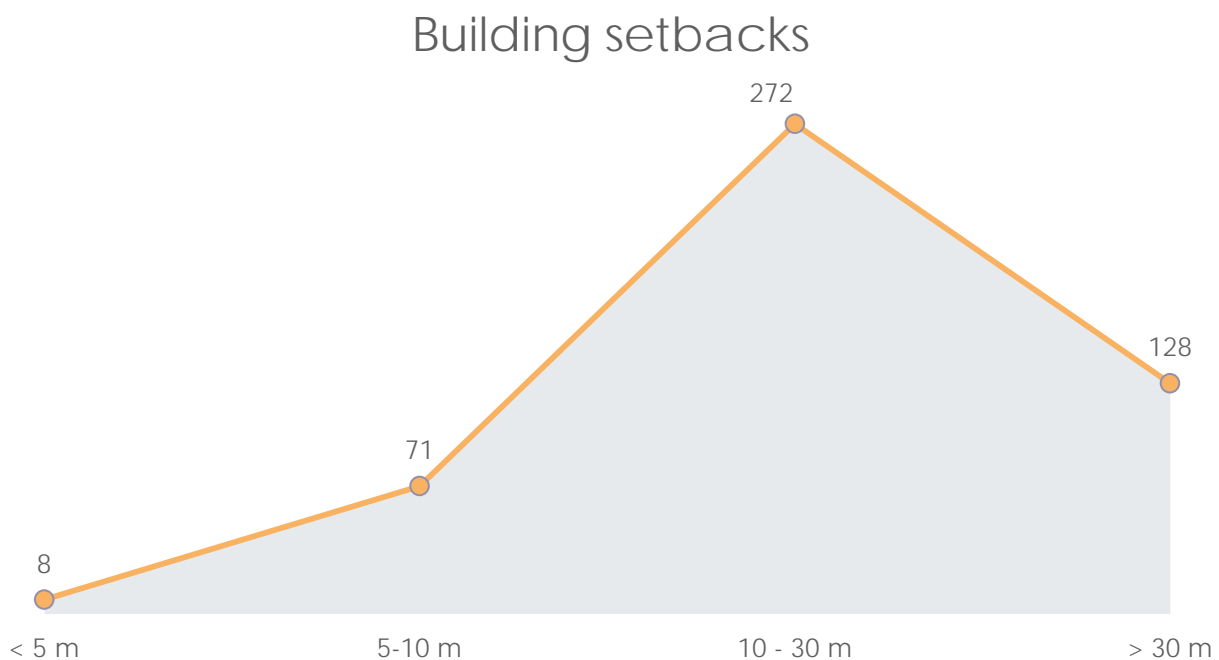
Figure 2 Building Setback Ranges

On Kashagawigamog Lake, properties with various building setback ranges were observed and recorded. Shown in figure 2 is the range of building setbacks for properties on the lake. Building setbacks for shoreline developments in Ontario should be at least 30 metres from the high water mark; however, older cottage buildings were permitted closer to the high water mark. On Kashagawigamog Lake, 37% of the properties surveyed were observed to be closer than 30 metres to the shoreline. These tend to be cottages or cottages re-developed into homes that were originally built when cottage developments were permitted closer to the water's edge. The primary problem associated with near-shore building setbacks is the limited area to buffer or filter contaminated runoff and wastewater from the main dwelling. They also disrupt the nearshore habitat corridor that many different animals use to move around the lake environment and into upland areas. While moving these buildings further back from the shoreline may not be a feasible or realistic option, naturalizing the shorelines of these properties would help address this issue.

A potential area of concern with building setbacks is having septic systems installed close to shore. Regular inspections and maintenance of septic systems can help prevent excess nutrients from entering the lake. Nutrients entering the lake can contribute to eutrophication, resulting in increased aquatic vegetation, low oxygen levels and algal blooms. Excess nutrient loading is one of the largest threats to water quality in lakes and rivers; it is everyone’s responsibility to do something to help protect the lake.

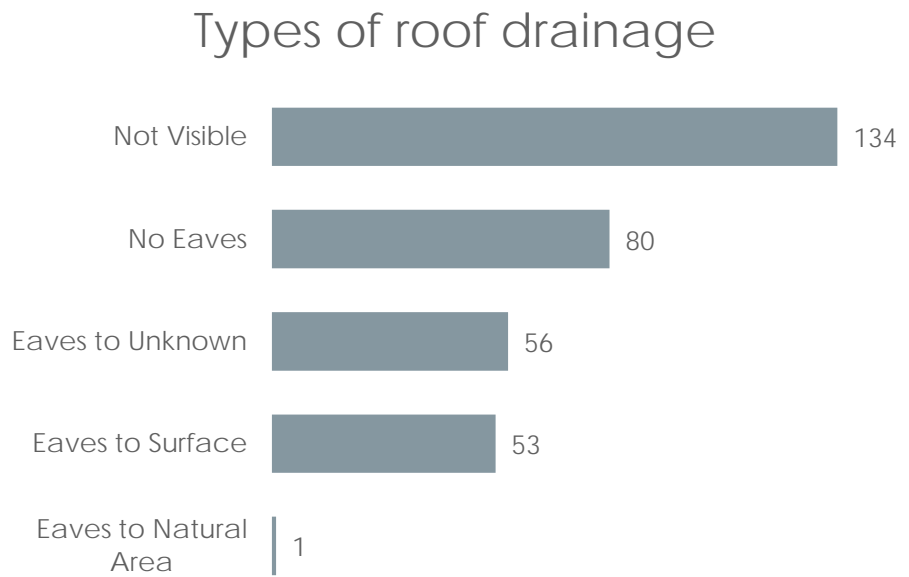
Figure 3 Roof Drainage types around lake

Few properties on the lake were identified with having eaves that drain into a rain barrel or with eaves that drain into a natural area. These numbers may be higher, as there were nearly 134 properties where we were unable to identify from the water where the eaves drained to. Because rain barrels are bulky to transport to a cottage area, the lake association may look into ways to make them more available to shoreline property owners. Another option is to install French drains next to cottages to encourage water to percolate into the ground instead of running directly overland into the lake.

Naturalizing shorelines on properties with near-shore building setbacks would help reduce runoff from entering into Kashagawigamog Lake, which could help reduce potential problems such as algae blooms and loss of oxygen in the water. Property owners can also manage this problem by ensuring they have eaves troughs with downspouts directed at natural or stone catch basins or rain barrels, as well as ensuring they have a properly functioning septic to process wastewater before it enters the lake. As septic systems do very little to process nutrients, it is also important to use phosphate free products.

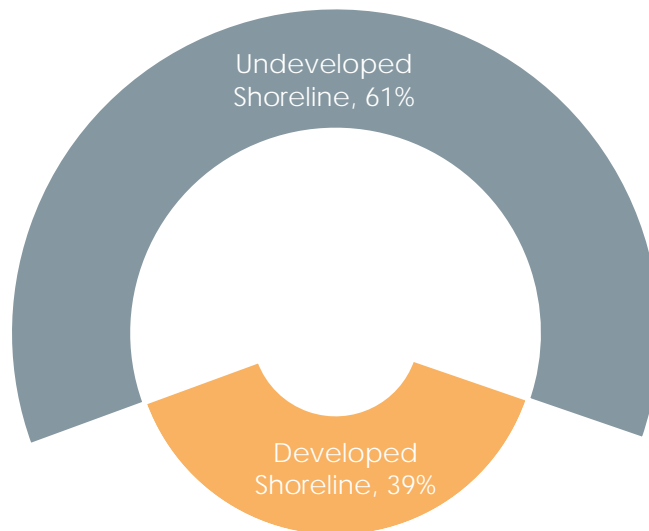
Figure 4 Shoreline Development Percentages

On Kashagawigamog Lake, 39% of properties with shoreline development features were observed and recorded within 3 metres of the lake. Shoreline development included the presence of man-made structures on the land or in the water within the first three metres of the shoreline. The diagrams below show the common structures present on the lake, as well as the total shoreline development.

It is recommended for the health of a lake to aim for a no more than 25% of the shoreline developed for access to the lake and recreational space leaving the rest natural. Beyond 25% development, critical functions of the lake that maintain its ecological integrity can begin to fail (Environment Canada, How Much Habitat is Enough? 2013) Therefore, 75% of the shoreline should be left in a natural state in order to provide maximum benefit to the health of the lake. Figure 1 shows the percentage of the entire assessed shoreline in each classification.

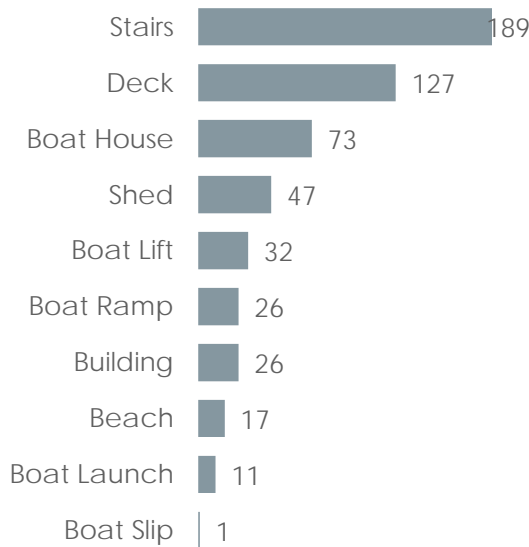
Figure 5 Structures On Lake

Shoreline development structures can, contribute to erosion, and can restrict wildlife access to and from land and water. Although some of these types of structures can have negative environmental impacts because they cover habitat, this can be partially mitigated by allowing vegetation to grow around the decks, boathouses, sheds, stairs, or other man-made structures.

Development along a shoreline can be done sustainably and in an environmentally sensitive fashion, as long as the structures are maintained and kept to a minimal footprint on the waterfront. Kashagawigamog Lake is much higher than the maximum recommendation of 25% development, by putting in some work the lake association will have met this target.

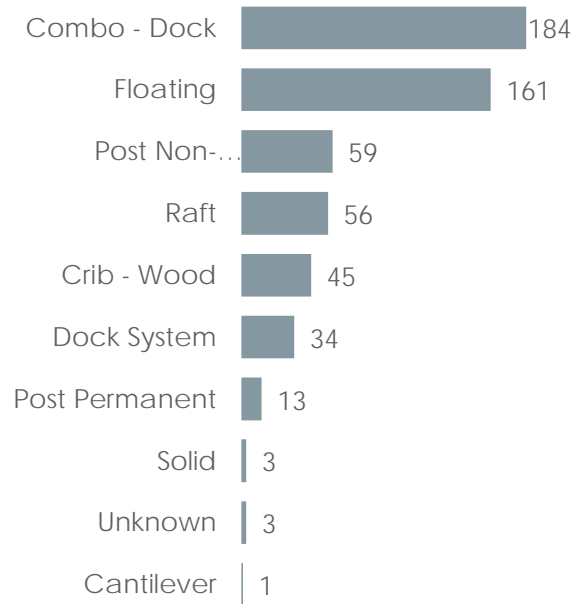
Figure 6 Docks on Lake

Small floating or post non-permanent docks are the best choice of docks as they have minimal contact with the lake bottom, and sit on or out of the water, which reduces the impact they have on the surrounding environment. In the future, if shoreline property owners need to replace their old or failing permanent post,

solid, or crib docks, they could consider a non-permanent post dock or floating dock, thereby limiting impacts to fish habitat and ensuring the natural flow of water remains unrestricted.

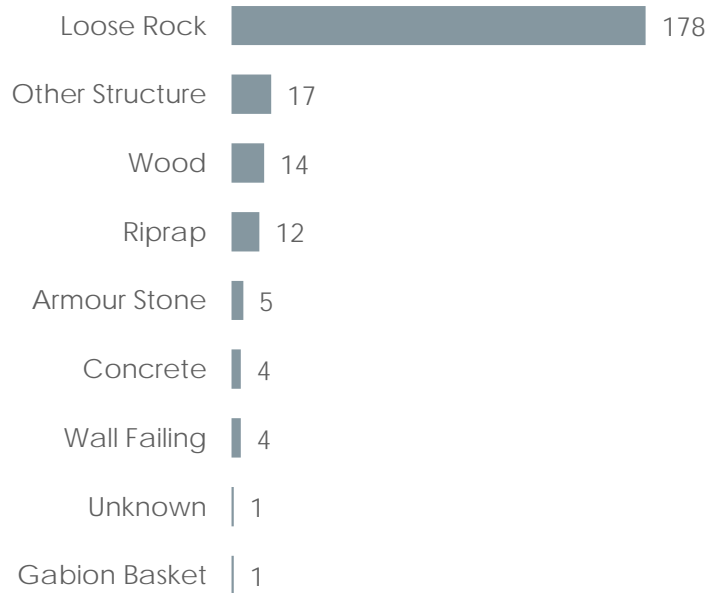
Figure 7 Retaining Walls on Lake

On Kashagawigamog Lake, the number of properties with retaining walls was counted and summarized below. Retaining walls, most often built to protect against erosion are a common feature on many lakes. 41% of properties on the lake have some sort of retaining wall with an average length of 36% of the total shoreline. The types and frequency of retaining walls is below in figure 7:

179 properties on Kashagawigamog Lake, or 41% of properties assessed, have a retaining wall. Of the retaining walls that are present the most common choice was loose rock (178 properties or 31% of properties assessed), followed by other structures acting as a retaining wall (17 properties or 3% of properties assessed). While retaining walls were a common choice in the past to combat erosion, we now know about their impact to the natural environment. Waves and wakes are reflected back from flat, hard surfaces with the same force as they strike the wall. This can cause excess turbulence in the water, which scours the sediments from the lake bottom. Solid walls also eliminate shoreline habitat and act as a barrier, preventing wildlife from reaching the water. Although some retaining walls such as rip rap or loose rock have fewer impacts than other retaining walls, shoreline property owners could consider alternative erosion control methods such as planting vegetated buffers or shoreline bioengineering if they ever wish to replace their current, old, or failing retaining wall. In the meantime, maintaining vegetation around the wall and allowing new vegetation to establish and grow will help reduce runoff and provide habitat for wildlife.

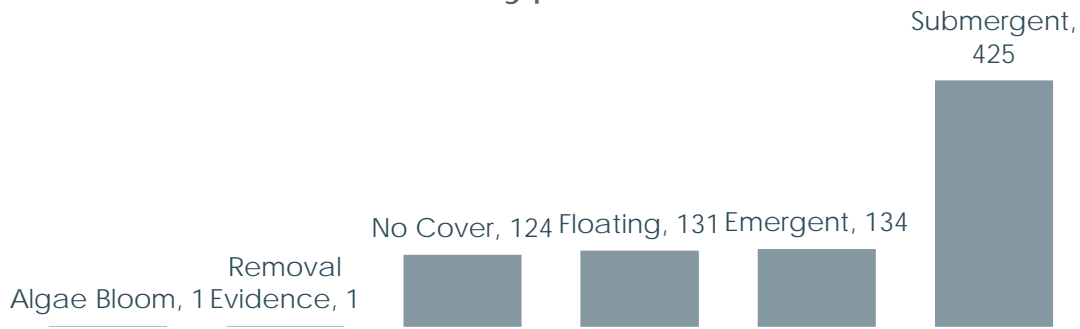
Figure 8 Aquatic Vegetation

On Kashagawigamog Lake, the number of properties with aquatic cover were observed and summarized. The presence and abundance of aquatic cover can vary throughout the year. Each assessed property could have one or more types of aquatic cover. Figure number 8 shows the number of properties on Kashagawigamog Lake had aquatic cover listed by type observed along their shoreline during the time of the assessments:

74% of properties on Kashagawigamog Lake had submergent aquatic plants while 24% of properties had emergent vegetation which is an important source of habitat for fish, and other aquatic organisms. Floating vegetation was found less frequently on Kashagawigamog Lake but is still an important part of the aquatic ecosystem, giving habitat to birds, frogs, dragonflies, and other wildlife. Aquatic cover can create places for wildlife to lay their eggs, provide a perch for predators of fish and insects and offer cover for wildlife. Shoreline property owners that are removing aquatic vegetation from their shoreline properties may be indirectly increasing the presence of invasive aquatic species. Aquatic vegetation may be a problem if there is an overabundance of it due to high nutrient levels entering the lake through runoff. By controlling nutrients entering the lake through well vegetated buffers and other actions shoreline property owners can maintain a healthy balance of aquatic habitat, and space for recreational activities.

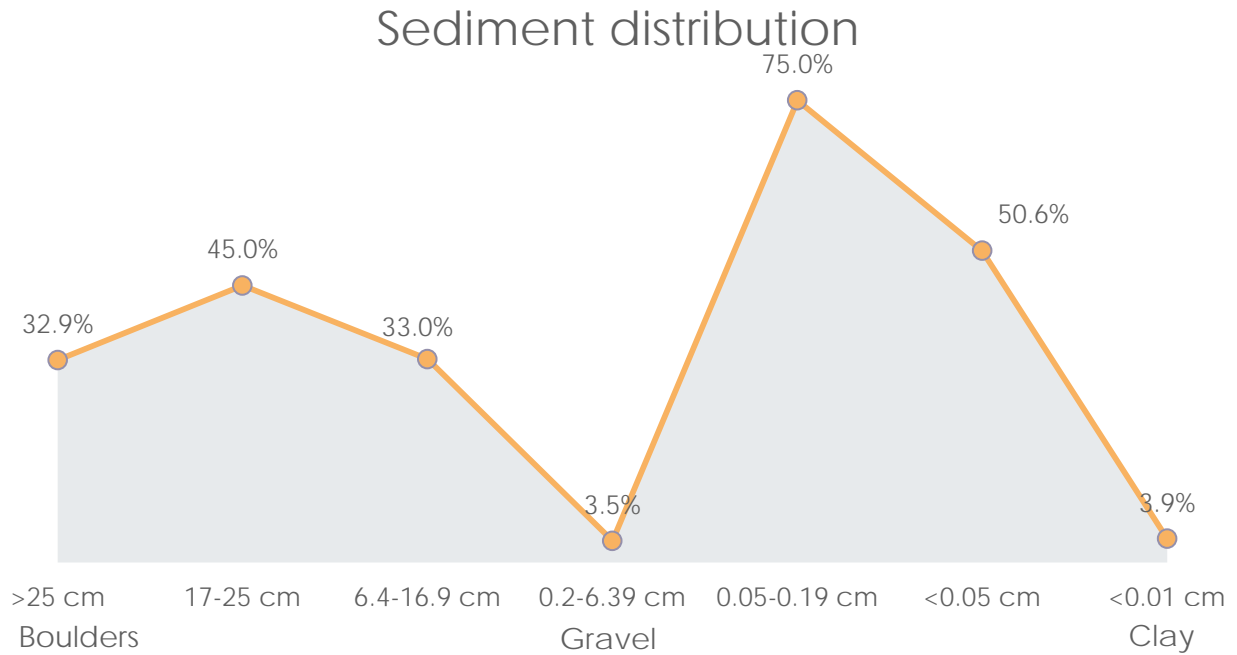
Figure 9 Sediment Distribution

On Kashagawigamog Lake, the aquatic substrate types were observed at each property. Figure 9 is the substrate size distribution on Kashagawigamog Lake. Aquatic substrate can be important habitat for fish and other aquatic wildlife and it is useful to document this feature to better inform future restoration projects on the lake. Kashagawigamog Lake was found to have a good variety of aquatic substrate throughout the lake for supporting aquatic biodiversity. Rubble and cobble provide great habitat for crayfish and spawning grounds for various species of fish while other environments provide excellent substrate for diverse aquatic vegetation.

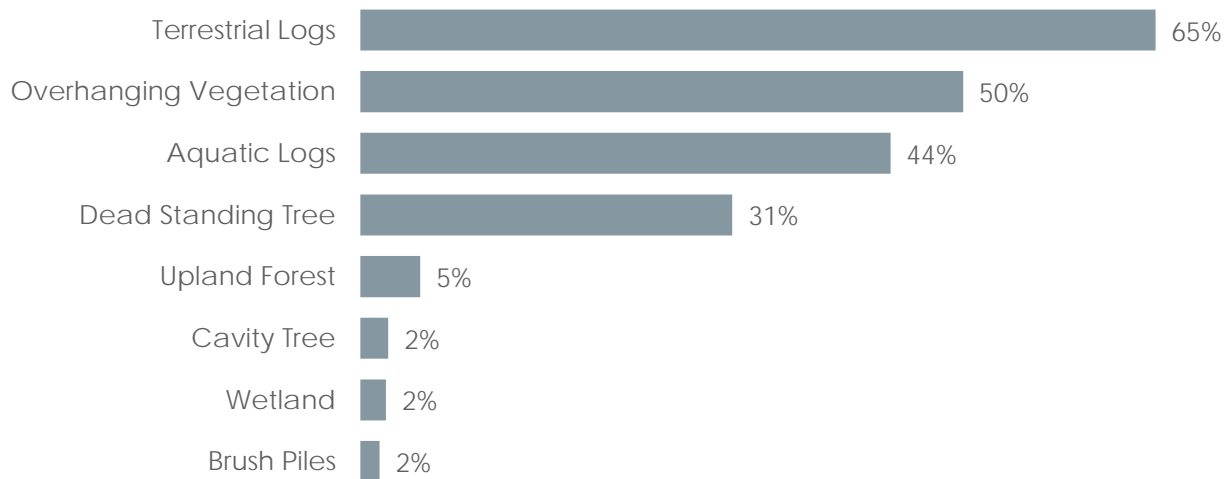
Figure 10 Habitat Present

Most common types of nearshore habitat on Kashagawigamog Lake were terrestrial logs, followed overhanging vegetation. Most properties on Kashagawigamog Lake had some amount of habitat present. Wildlife provides us with many enjoyable and beneficial activities from bird watching and wildlife photography to pest control, seed dispersal, nutrient cycling and pollination, to name just a few. It is important for there to be a rich and diverse range of habitats along the lakeshore to ensure a healthy lake environment. Figure 10 summarizes the lake nearshore habitat.

It is important to leave large trees that are dead and dying in place, as they provide important habitat for a number of different species. In Ontario, more than 50 species of birds and mammals depend on cavity trees for nesting, rearing young, roosting, feeding, storing food, escaping predators, and hibernating. Fallen logs on land provide habitat for small mammals such as moles, woodpeckers, toads and insects. As the log decomposes, reptiles and amphibians lay their eggs in the moist wood. A decaying log is also great habitat for beetles, and ants that burrow under the bark and lay eggs. In the water, logs provide important fish habitat by providing refuge for small fish, and spaces for ambush predators such as pike to conceal themselves. By leaving dead and decaying brush and logs in place, you are helping contribute to a healthy and vibrant species community.

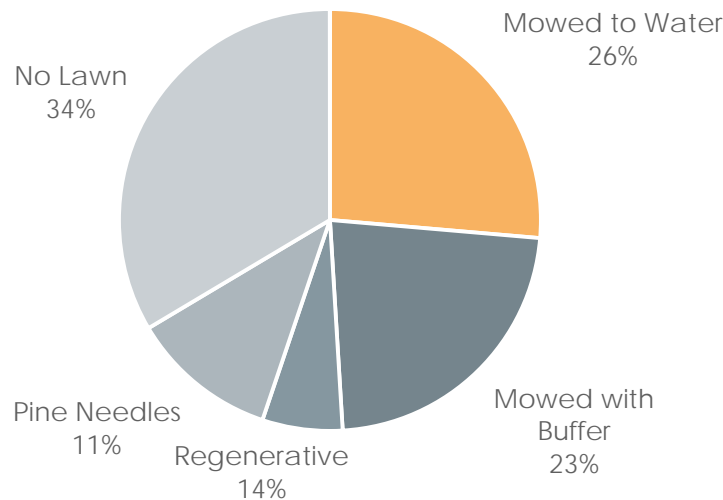
Figure 11 Lawn types

On Kashagawigamog Lake, the number of properties with lawns, either mowed or regenerative, was observed. 35% of properties with lawns were observed to have a mowed lawn to the water's edge. Natural ground cover and native vegetation, in comparison, slows runoff and allows filtration, removing many contaminants,

pollutants, nutrients, sediment and other substances. These substances can be carried into the lake by runoff and can harm water quality and local ecological integrity. Lawn grasses also have short root systems and do not bind the soil well, which can lead to problems with erosion.

In areas close to shore, a lawn is generally not a good choice of ground cover as 55% of precipitation runs off mowed grass directly into the lake, instead of returning to groundwater. If shoreline property owners wish to mitigate this, they could consider allowing vegetation to regenerate on its own or by actively planting native trees, shrubs, grasses, or alternative ground cover. The roots of the vegetation will grip the soil, which can help prevent erosion. Allowing mowed lawns to regenerate to a more natural state promotes water conservation and protects surface and groundwater resources. Properties with regenerative lawns are encouraged to allow this natural process to continue and to enhance regeneration by planting native shrubs and trees.

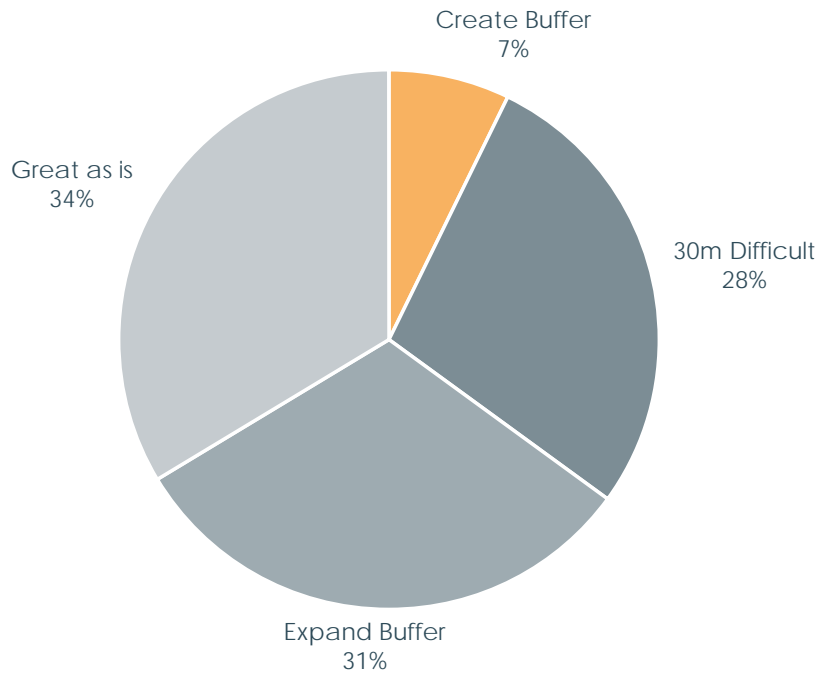
Figure 12 Buffer Recommendations

Arguably the most important element of a shoreline that property owners can easily influence is shoreline buffers. Buffers are an important element of natural shorelines that help filter nutrients, reduce erosion, and provide habitat. On Kashagawigamog Lake, 7% of properties have enough room between the main residence and the lake for the creation of a shoreline buffer to provide benefits to water quality and habitat. 34% of properties were noted to have great buffers as they are. In order to ensure the sustainability of a healthy lake environment it is important that natural buffers make up at least 75% of the lake shoreline, preferably as much as 80%.

There are a number of options shoreline property owners have to improve or increase the size of their buffer. Watersheds Canada and the Canadian Wildlife Federation is offering shoreline naturalizations funded through the Department of Fisheries and Oceans Canada. The data collected previous in this report was used to calculate shoreline naturalization priorities. The categories are as follows:

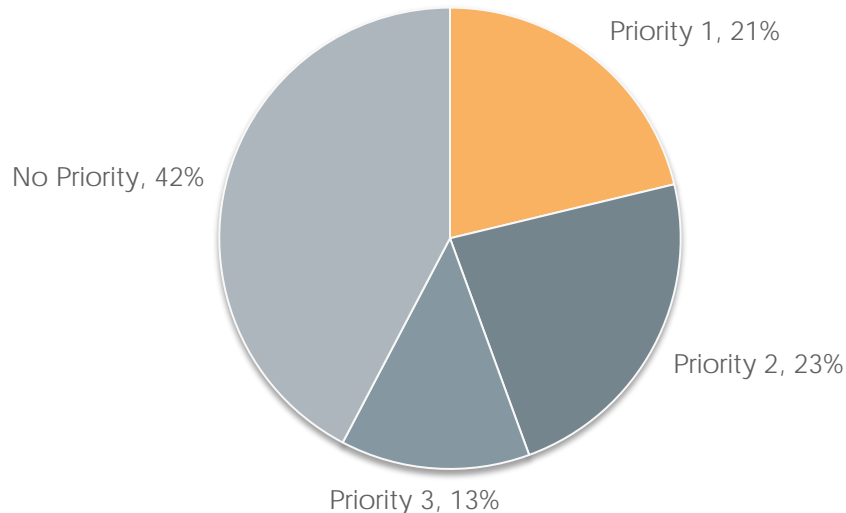
Figure 13 Naturalization Priorities

- Priority 1: The best candidates for naturalization efforts. These properties have more than 50% of their shoreline classified as ornamental. Additionally these properties have at least 30 metres of space between the water's edge and their main building (house/cottage). These properties are recommended to either create a buffer or expand their current buffer.

- Priority 2: The second best candidates for naturalization efforts. These properties have more than 25% of their shoreline classified as ornamental. However, some of these properties have less than 30 metres of space between the water's edge and their main building (house/cottage), which could make planting more difficult or less substantial. These properties are also recommended to either create a buffer or expand their current buffer.

- Priority 3: These are the third best candidates for naturalization efforts. These properties are already mostly natural or regenerative, and less than 25% ornamental. However, some of these properties have less than 30 metres of space between the water's edge and their main building (house/cottage), which could make planting more difficult or less substantial.

There is a great deal of potential for shoreline naturalization on Kashagawigamog Lake as greater than 20% of the properties on the lake could potentially be a candidate for naturalization based on our assessment for shoreline naturalization projects. Buffer zones are the ribbon of life, providing over 90% of aquatic and terrestrial wildlife with essential habitat needed at some point throughout their various life stages, to mate, rear young, find food, or take shelter. Property owners who do not have 30 metres of space inland from the water's edge are encouraged to plant where they can. If support is needed in naturalization efforts, contact Coalition of Haliburton Property Owners' Associations at www.cohpoa.org or www.watersheds.ca
